## AIRPLANE “TIP OVER”©

*by Dan Pemble, McDonnell Douglas/Boeing Field Rep. (retired September, 2009) – July 15, 2015*

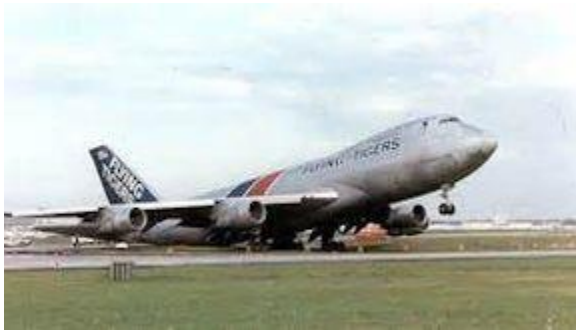
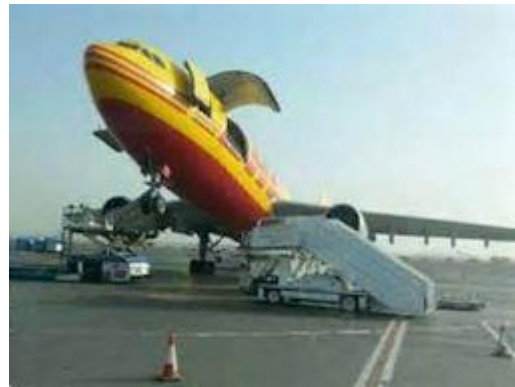
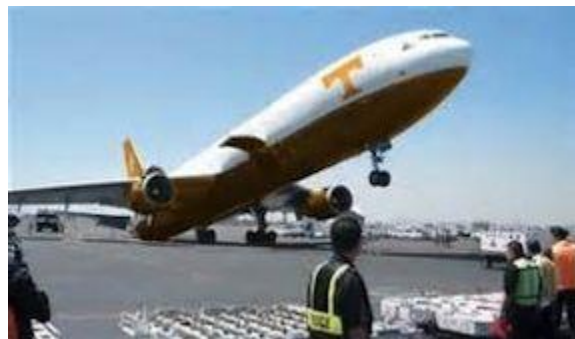
“Tip over” of some airplanes can and does in fact occur from time to time due to unplanned/unanticipated shifts in the airplane’s center of gravity. Such tip overs have occurred while airplanes were in maintenance status as well as during in-service operations. Please see the following photos of tip over events; these photos remind me of a couple related matters: (1) A “Tip Over Computer” was developed by Douglas Aircraft for most all Douglas-built airplanes and was supplied at no cost to operators. These computers were cleverly-designed “circular slide rules” used to calculate the CG and show the range where tip overs could potentially occur. Basically, for an airplane to remain in a stable condition, its center of gravity must never be allowed to go aft far enough to get close to the main landing gear centerline or the wing jacking point, whichever applies. (2) PSA, the first American operator of the MD-80, actually had “ballast trays” to accommodate lead weights installed in the nose wheel well in their initially-delivered airplanes. PSA operated many frequent & short-duration MD-80 flights up and down the coast of California. These flights were very popular with business travelers. PSA believed that many business travelers would prefer to occupy the aft cabin seats so that after arrival at the gate they could rapidly exit the aircraft via the aft ventral stairs. As such, PSA felt the CG could shift too far aft to the point of a possible tip over. However, the ballast trays were never utilized and no tip overs occurred on PSA MD-80’s during 1980-1987 while I was with them as their McDonnell Douglas Field Service Representative.
