## **AIRPLANES & LIGHTNING STRIKES!®**

by: Dan Pemble, McDonnell Douglas/Boeing Field Service Representative – Retired September 9, 2009

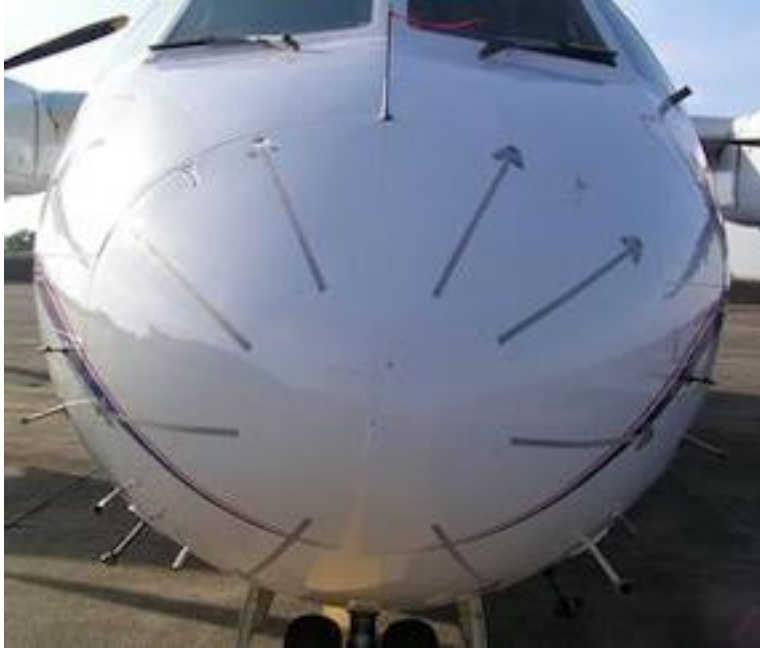
To protect the radome from damage in the event of a direct-hit lightning strike, there are metallic electrically-conductive "lightning diverter strips" attached to the radome. The lightning diverter strips are evenly spaced around the circumference of the radome's exterior. The aft end of each individual diverter strip is electrically-bonded to a metal ring at the inner aft circumference of the radome; in turn, the metal ring is electrically-bonded to the radome hinges that connect to the aircraft; in fact, all of the aircraft's external skin, frames, and metallic parts (aluminum, steel, etc.) are electrically-bonded together.

Typical Radome Lightning Diverter Strips

The lightning diverter strips are able to guide high-energy lightning strikes via the electrically-bonded, continuous-conductive path through the length of the airplane's external structure. The electrical path may end at numerous "static wicks" that are usually installed on the trailing edges of the wings, flaps, aileron, elevator, rudder, and tail cone. The static wicks have a non-metallic outer covering and an inner electrically-conductive "stem" that is electrically-bonded to the airplane structure. The static wicks main function is to allow static electricity buildups on the exterior of the aircraft to bleed off. However, due to the energy of lightning strikes exiting the aircraft structure via the static wicks, in many cases when an airplane takes a lightning hit, some wicks may be completely "blown off" the structure to which they were attached. In other cases, lightning strikes may actually exit the aircraft at different areas of the structure. A lightning strike typically will hit the nose or wing tip and its electricity will then travel through the plane's exterior skin and leave on the opposite end. This allows the plane to take the lightning strike, without affecting the interior or its occupants and equipment at all, and with minimal damage to the structure. During the certification process for all commercial airliners, tests are required to demonstrate the airplane's structure and systems' immunity to lightning strike damage.
