## **THE UKRAINE-BUILT ANTONOV AN-124 “BEHEMOTH”®**

*by Dan Pemble, McDonnell Douglas/Boeing Field Service Representative (retired September 2009) – June 30, 2020*

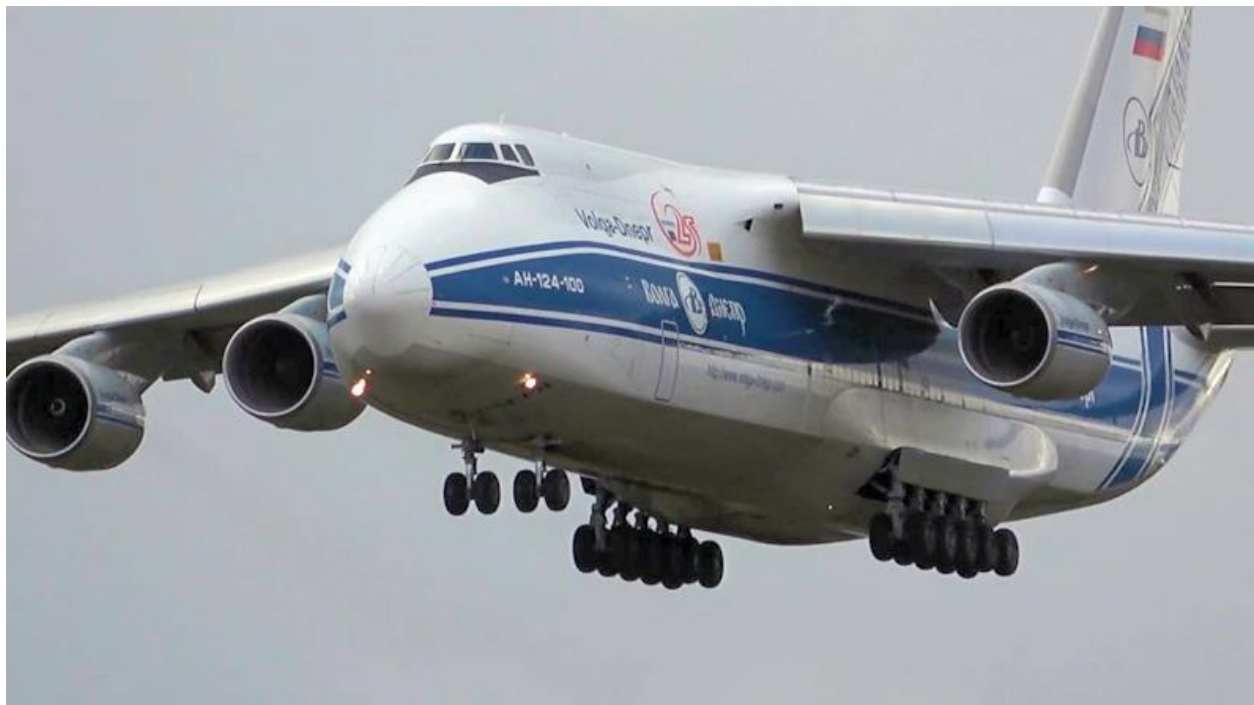
As seen in the photo, this airplane has 5 main landing gear assemblies on each side with 2 tires on each gear for a total of ten main landing gear assemblies with 20 total tires. There are 2 each nose landing gear assemblies each with 2 tires. Like other “heavy lifter” cargo airplanes, the AN-124’s nose landing gear will “kneel down” to afford access for front loading once the nose section of the fuselage is raised up.
